QM-8 Field Joint Protection System Final Report
Volume 7

June 1989

TWR-17591 VOL. VII
QM-8 FIELD JOINT PROTECTION SYSTEM FINAL REPORT
VOLUME 7
FINAL REPORT

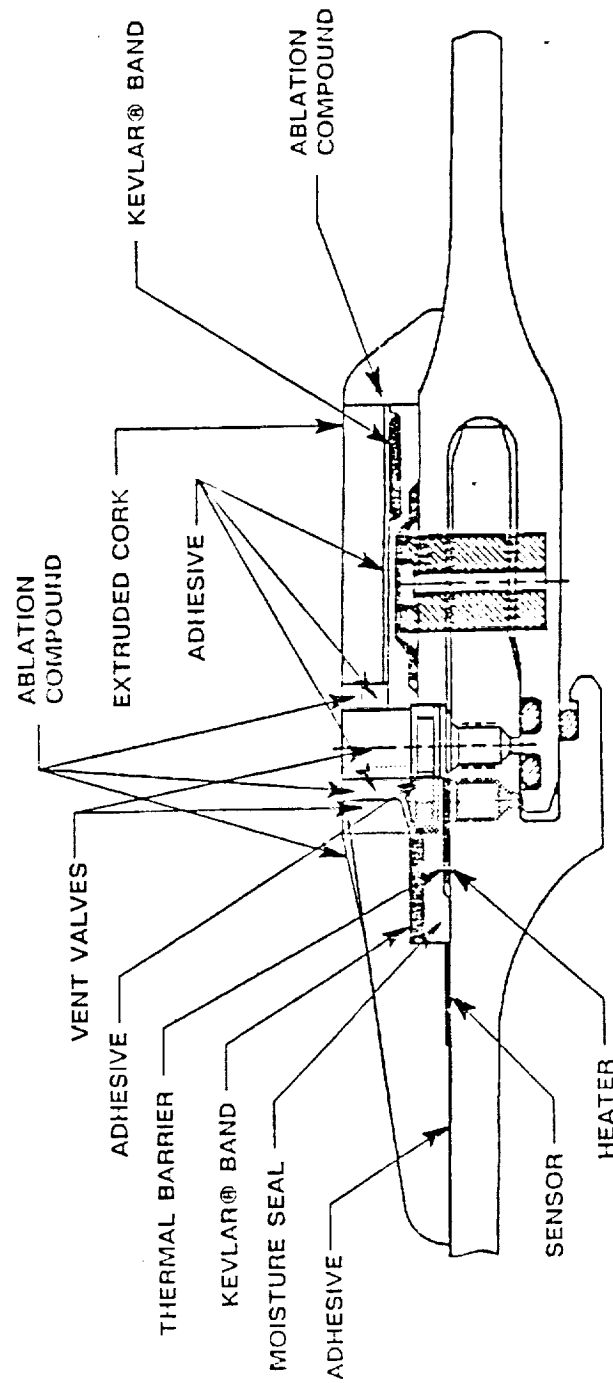
FIGURE 1

Qualification Motor (QM) 8 was test fired on 20 January 1989. The three field joints of the motor were protected by the Joint Protection Systems (JPS). See Figure 1. The JPS heaters were turned on prior to the test firing to assure the joint O-ring temperature was between 85 and 122 degrees F at the time of ignition. The purpose of the moisture seal is to prevent entry of rain into the joint. The cork insulation provides thermal protection for the JPS during flight.

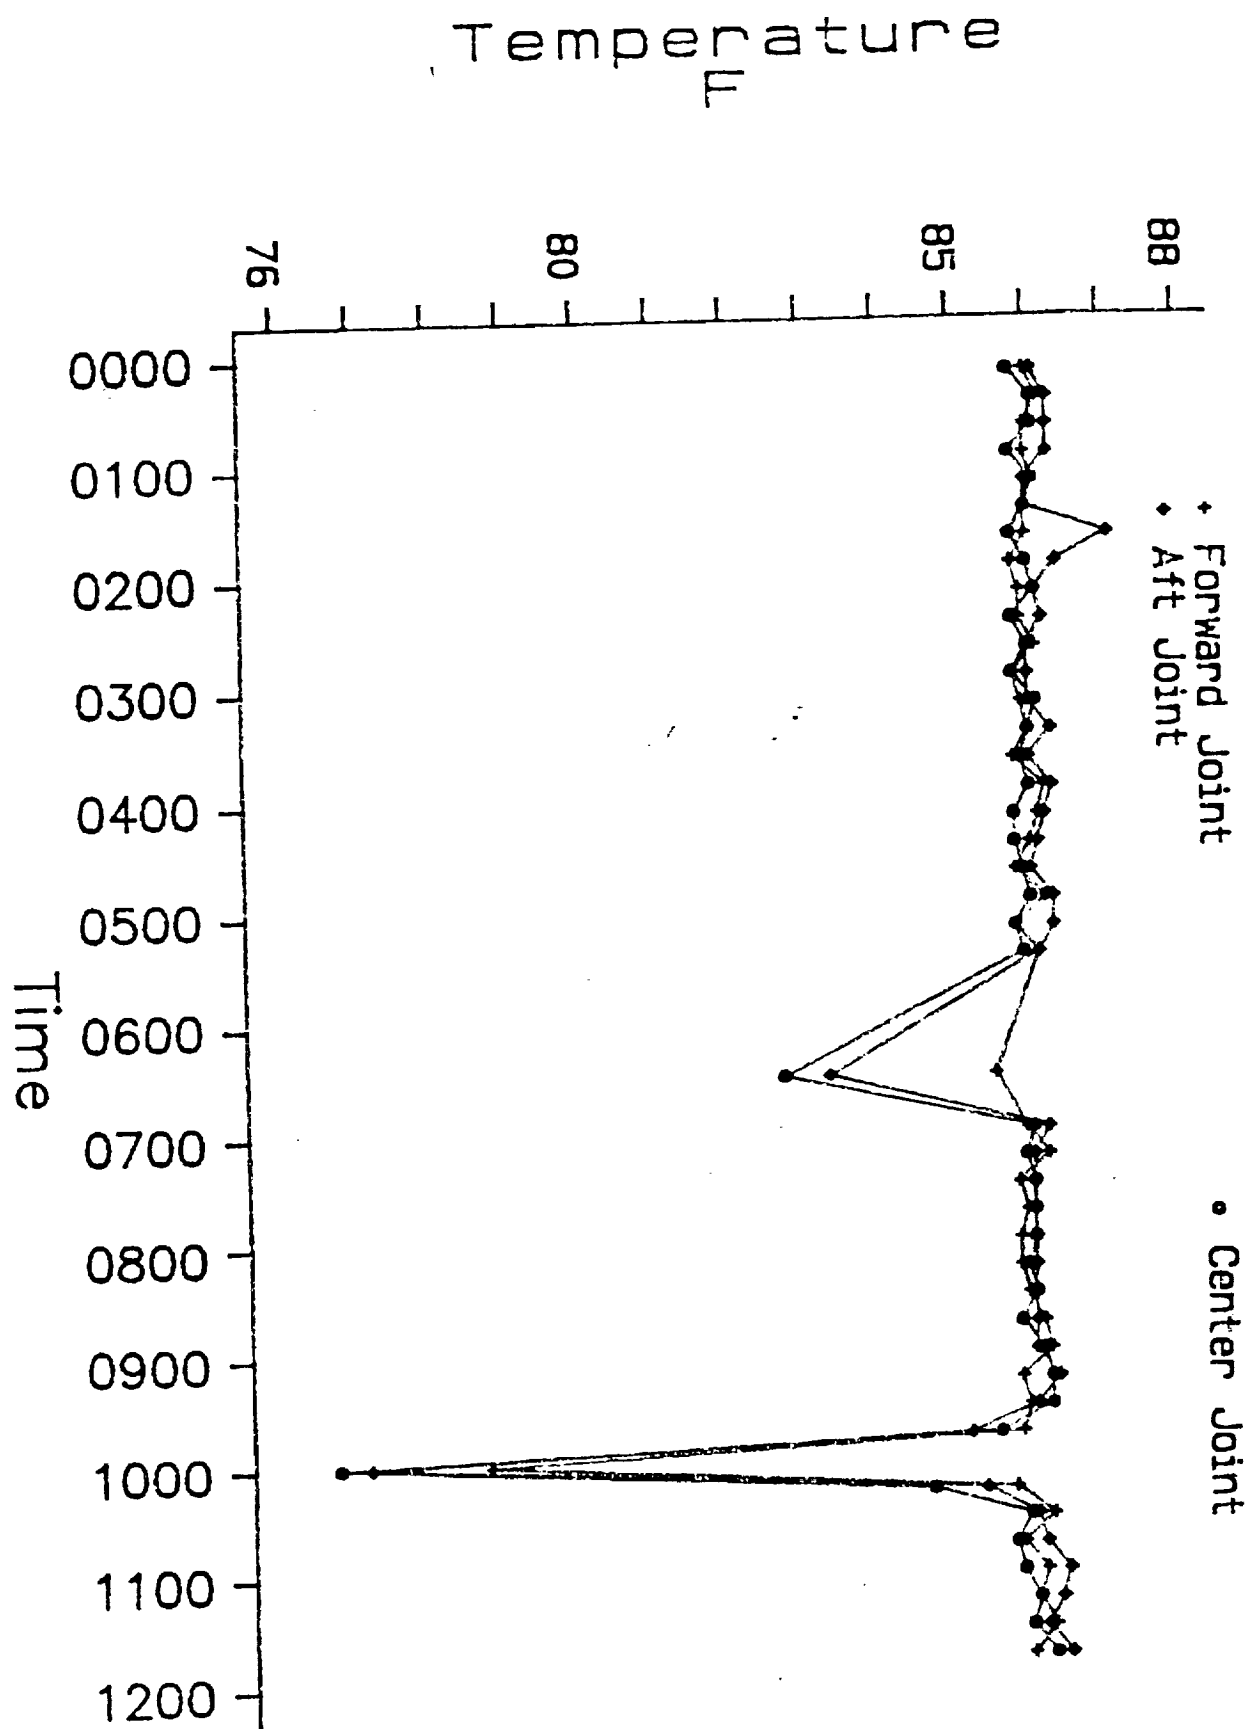
RTD at 86° with a maximum deviation of -0.6° to +0.5°. The four temperature sensors at each field joint were continuously monitored and the coldest sensor was manually selected for temperature control. Figure 2 is a plot of the temperature of the controlling RTD of the three field joints. The drop in temperature at 0600 and 1000 hours was due to heater power shut off.
